From: [Peterson, Mary](#)
To: [Miller, Garyg](#); [Sanchez, Carlos](#); [Coltrain, Katrina](#); [Coats, Janetta](#)
Cc: [Meyer, John](#); [Edlund, Carl](#); [Opalski, Dan](#); [Gray, David](#); [Carroll, Craig](#)
Subject: RE: Final follow up... Inspections of SJRWP - questions
Date: Saturday, September 9, 2017 2:49:38 PM
Attachments: [image001.png](#)
[image015.png](#)
[image016.png](#)
[image017.png](#)

Subject: Final follow up... Inspections of SJRWP - questions

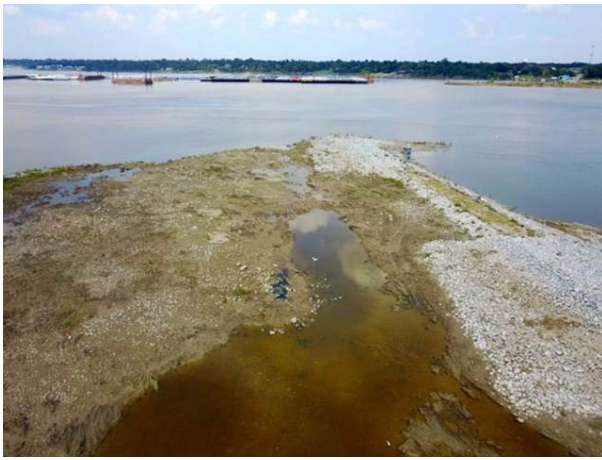
6. Drone footage from sometime since the weekend captured the attached image. If you look in the middle of the image, you see bluish looking material of some sort. When I first saw it, I thought it was liner, but when I zoom in, it appears to be a viscous bluish material. It’s hard to tell. I hope that you have been able to confirm what that material is.

No viscous dark material has been observed on the cap. It is not clear what the image may be showing, but in the past organic material from the river has had a dark appearance. The paper-mill waste in the waste pits generally has a grayish color. as seen in the attached photograph taken prior to the installation of the cap.
